NAVAL POSTGRADUATE SCHOOL

THESIS

**CORROSION AND THERMAL PROCESSING IN COLD
GAS DYNAMIC SPRAY DEPOSITED AUSTENITIC
STAINLESS STEEL COATINGS**

June 2016

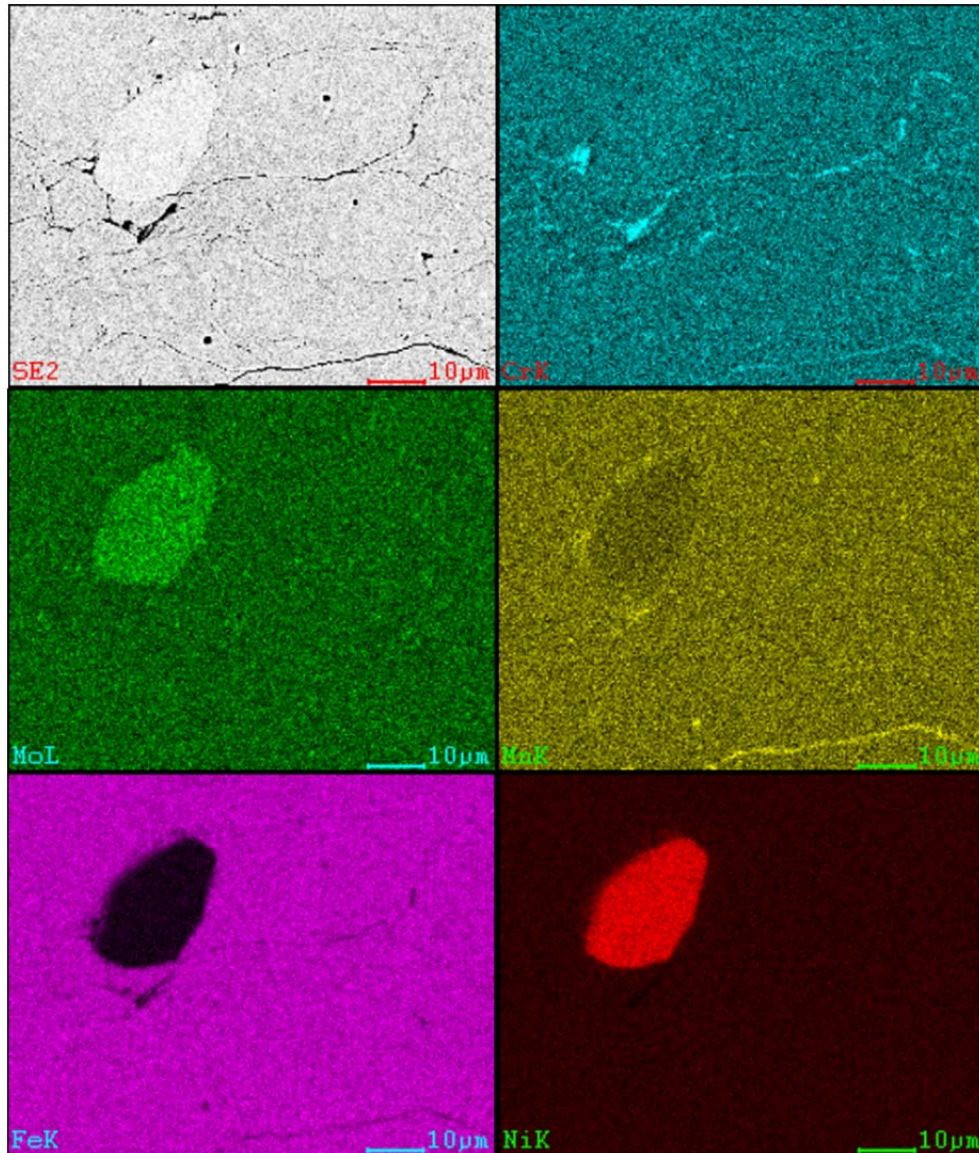
Figure 26. EDS maps of high nickel particle in 5002 as-sprayed powder sample.

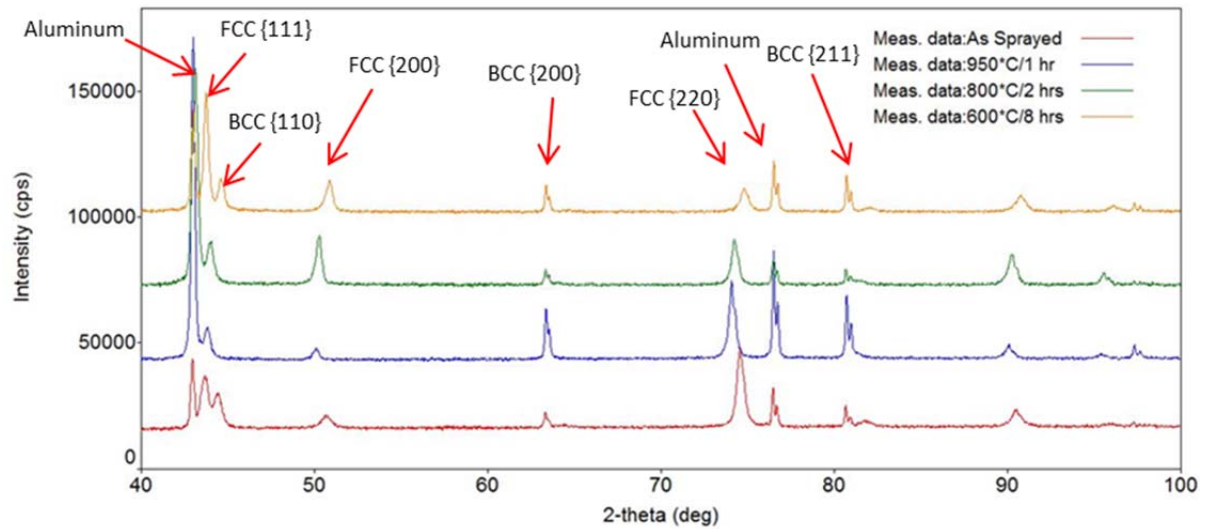
Figure 27. X-ray diffraction spectra from 5001 powder samples.

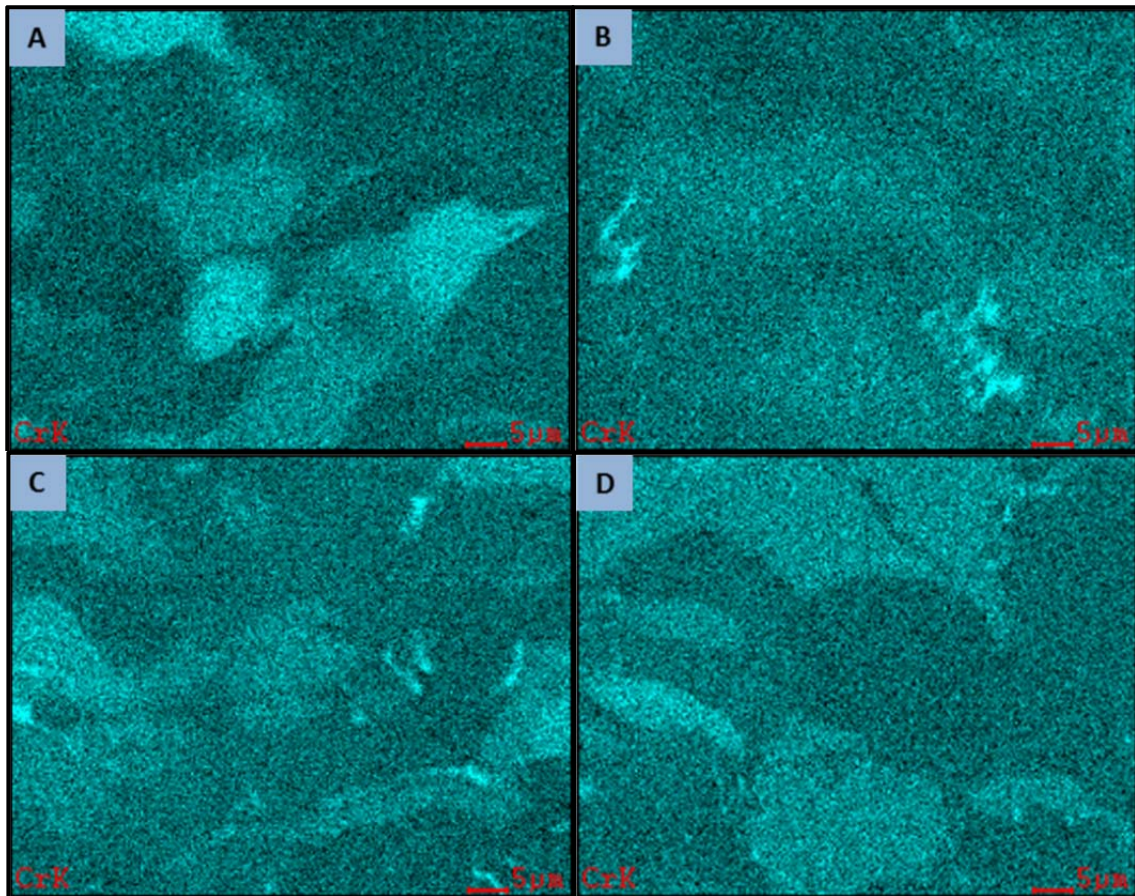
Figure 30. EDS maps of chromium distribution in PG-AMP-10 powder samples showing high chromium areas likely associated with ferrite grains. (a) as sprayed; (b) 950°C/1hr; (c) 800°C/2hrs; (d) 600°C/8 hrs.

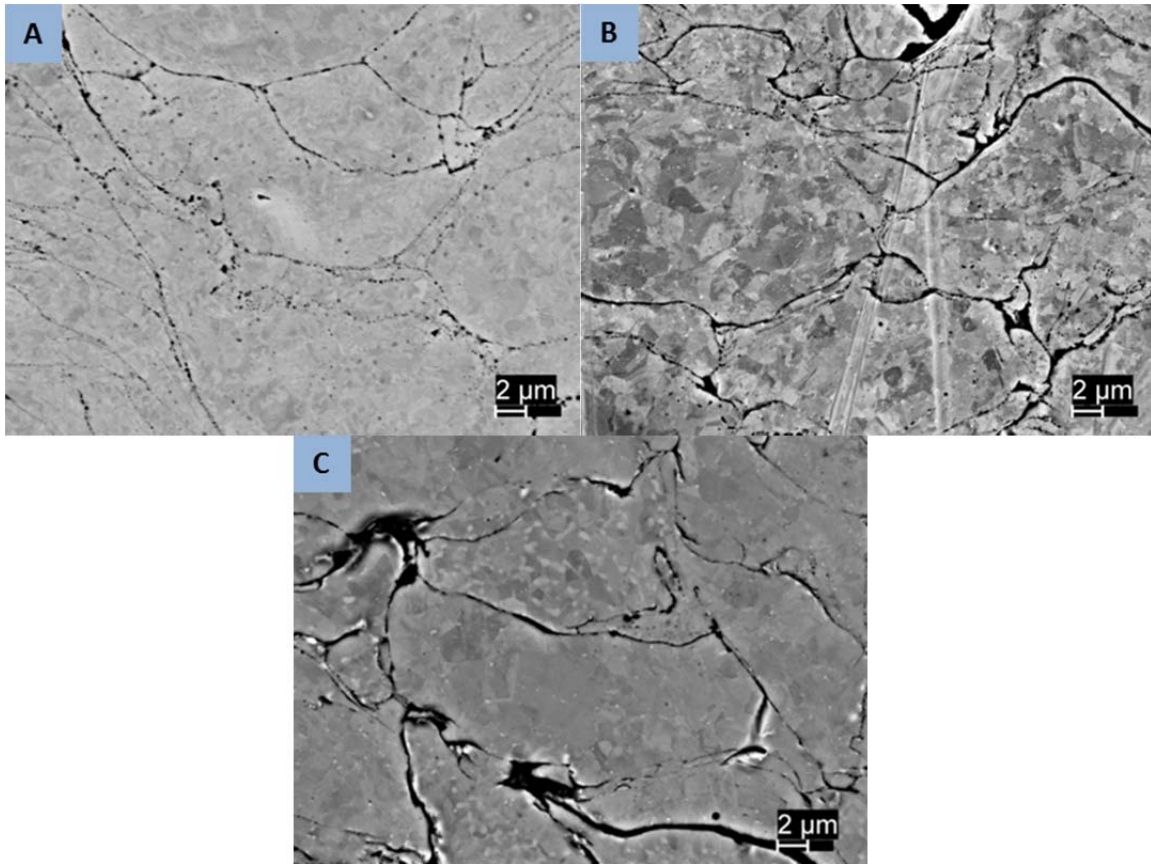
Figure 32. Backscatter micrographs of 800°C/2 hrs heat treated samples showing evidence of recrystallization and grain growth. (a) 5001; (b) 5002; (c) PG-AMP-10

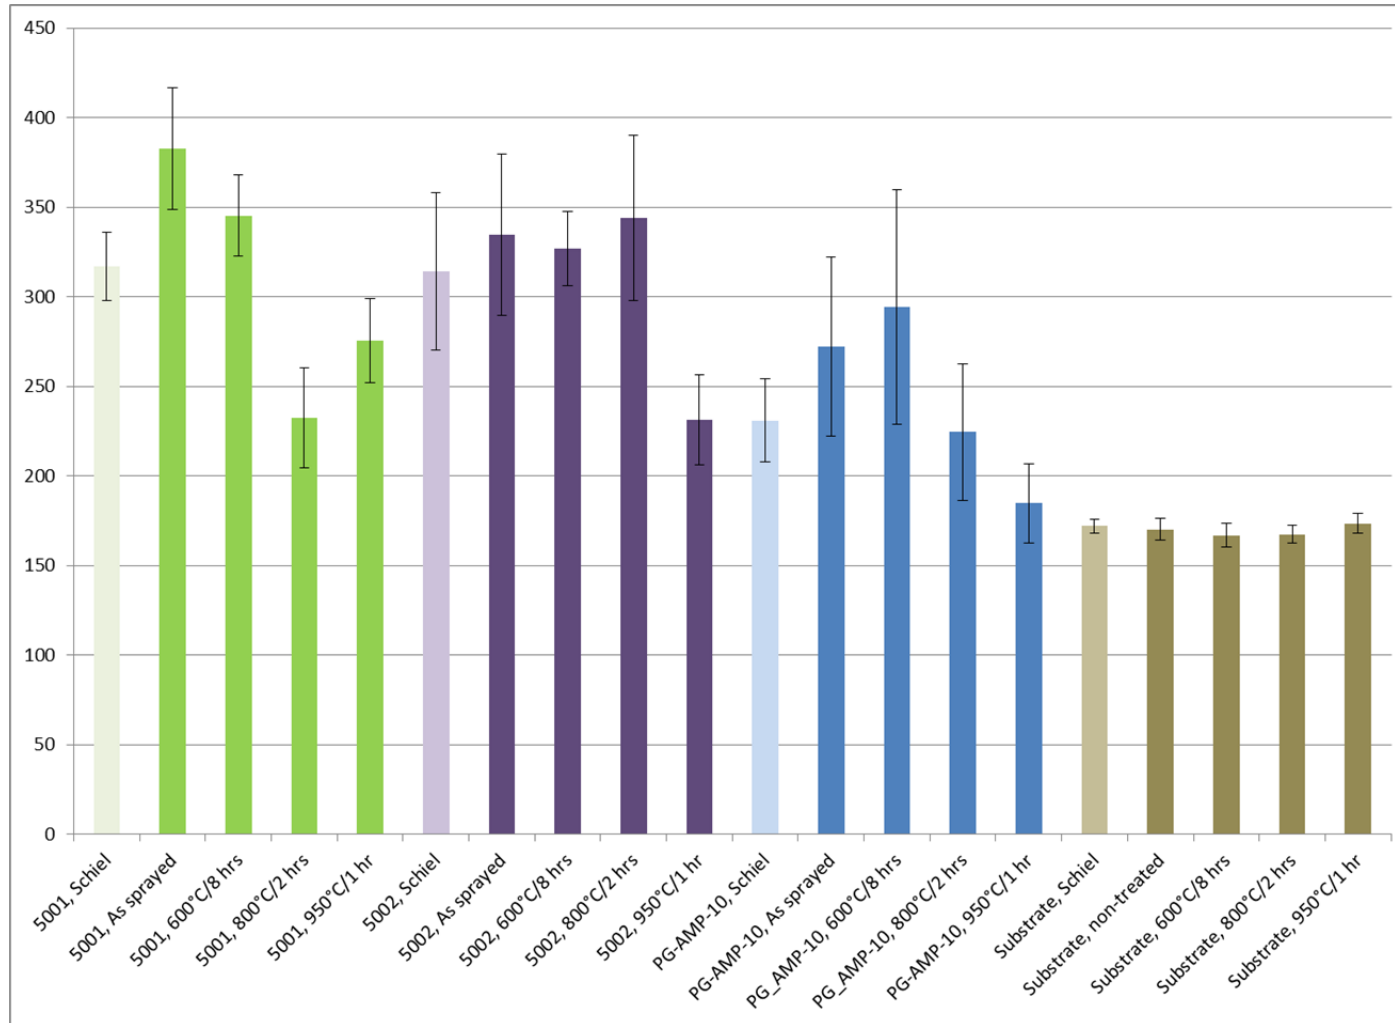
Figure 33. Average coating hardness. Results from Schiel [3] included for comparison.

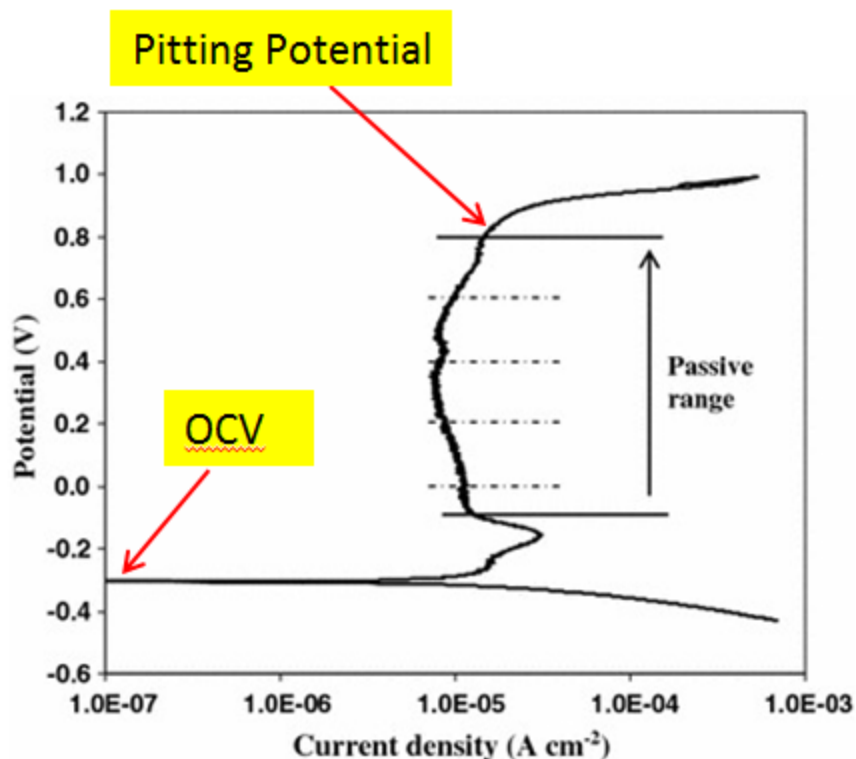
Figure 34. Typical polarization curve showing passivation behavior of 316L stainless steel in 0.05M H₂SO₄. Adapted from: [56].

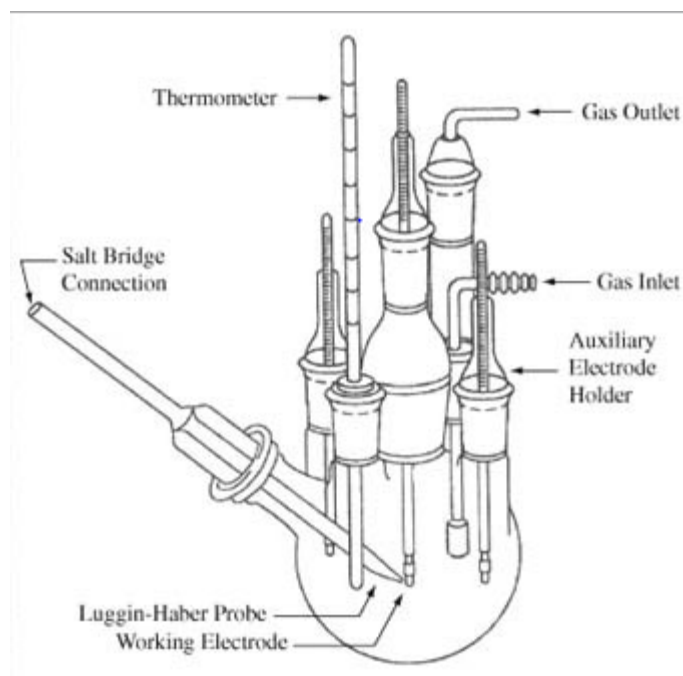
Figure 35. Schematic diagram of a typical polarization testing cell. Source: [56].

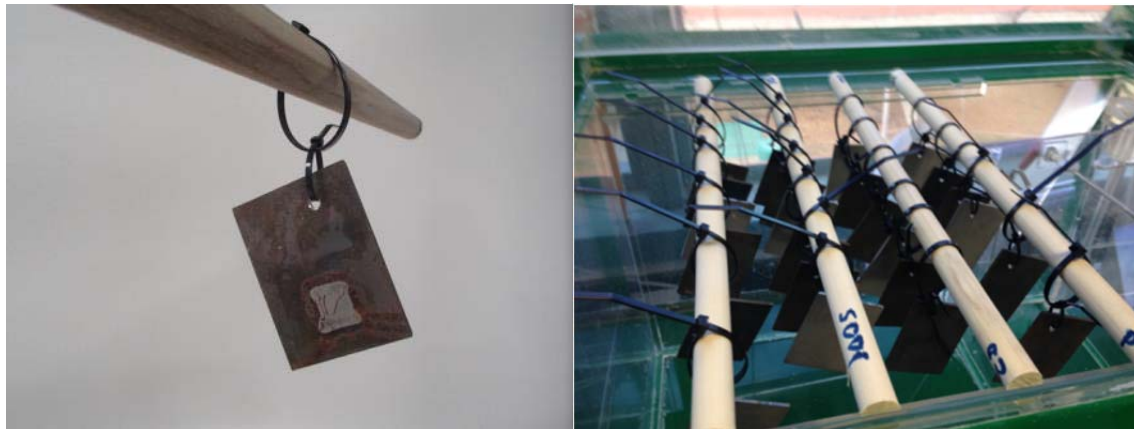
Figure 36. Method of supporting samples in salt fog chamber

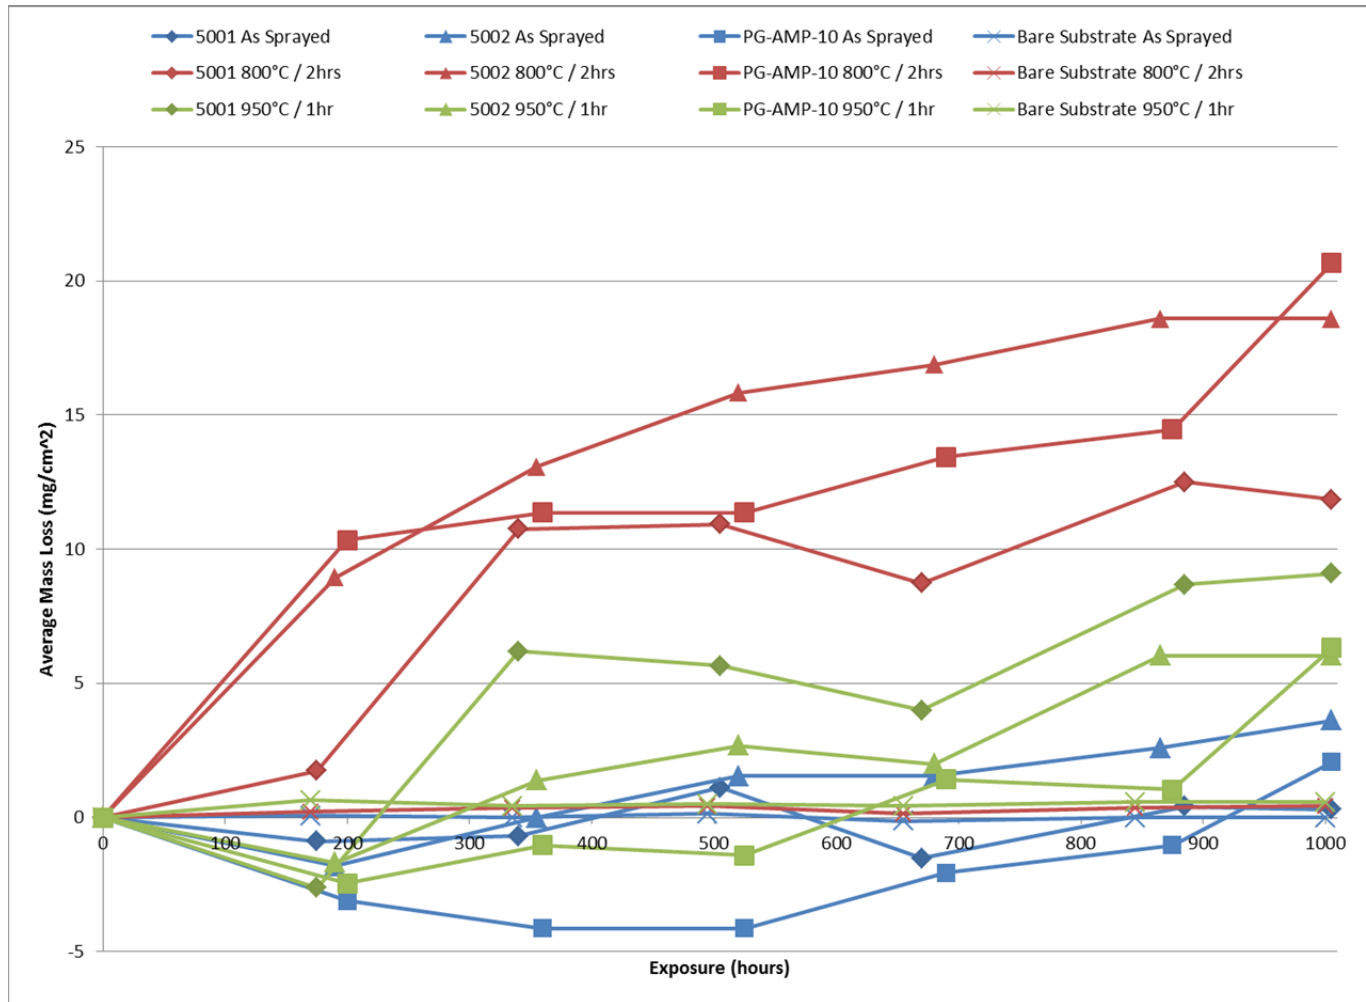
Figure 37. Observed weekly salt fog sample mass loss.

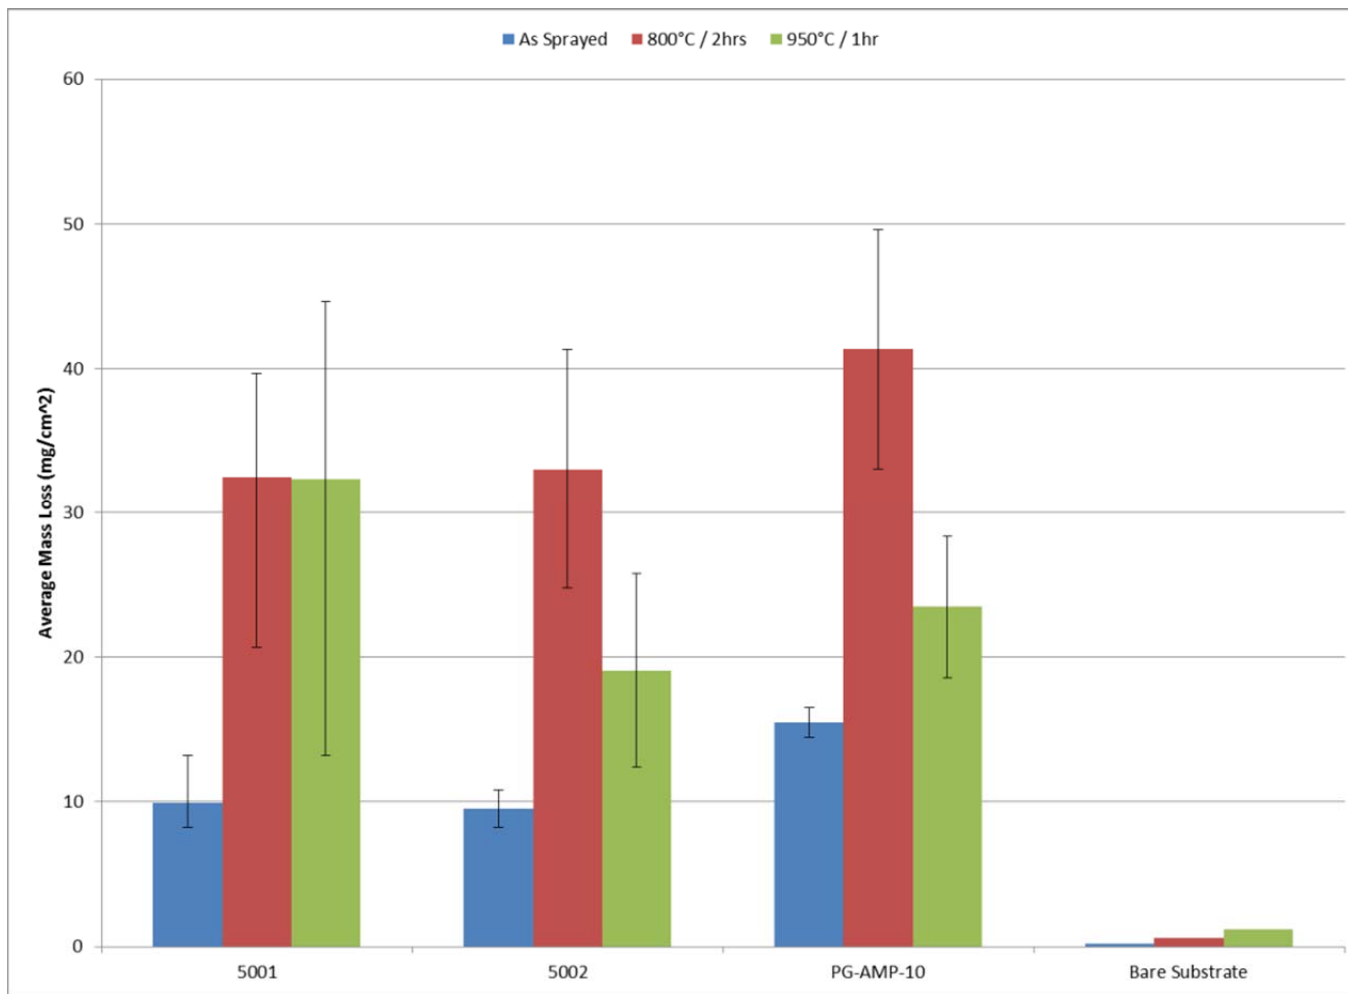
Figure 38. Mass loss measured after 1000 hrs salt fog exposure and cleaning of samples with 10% nitric acid

Error bars represent maximum and minimum sample values observed within the group.

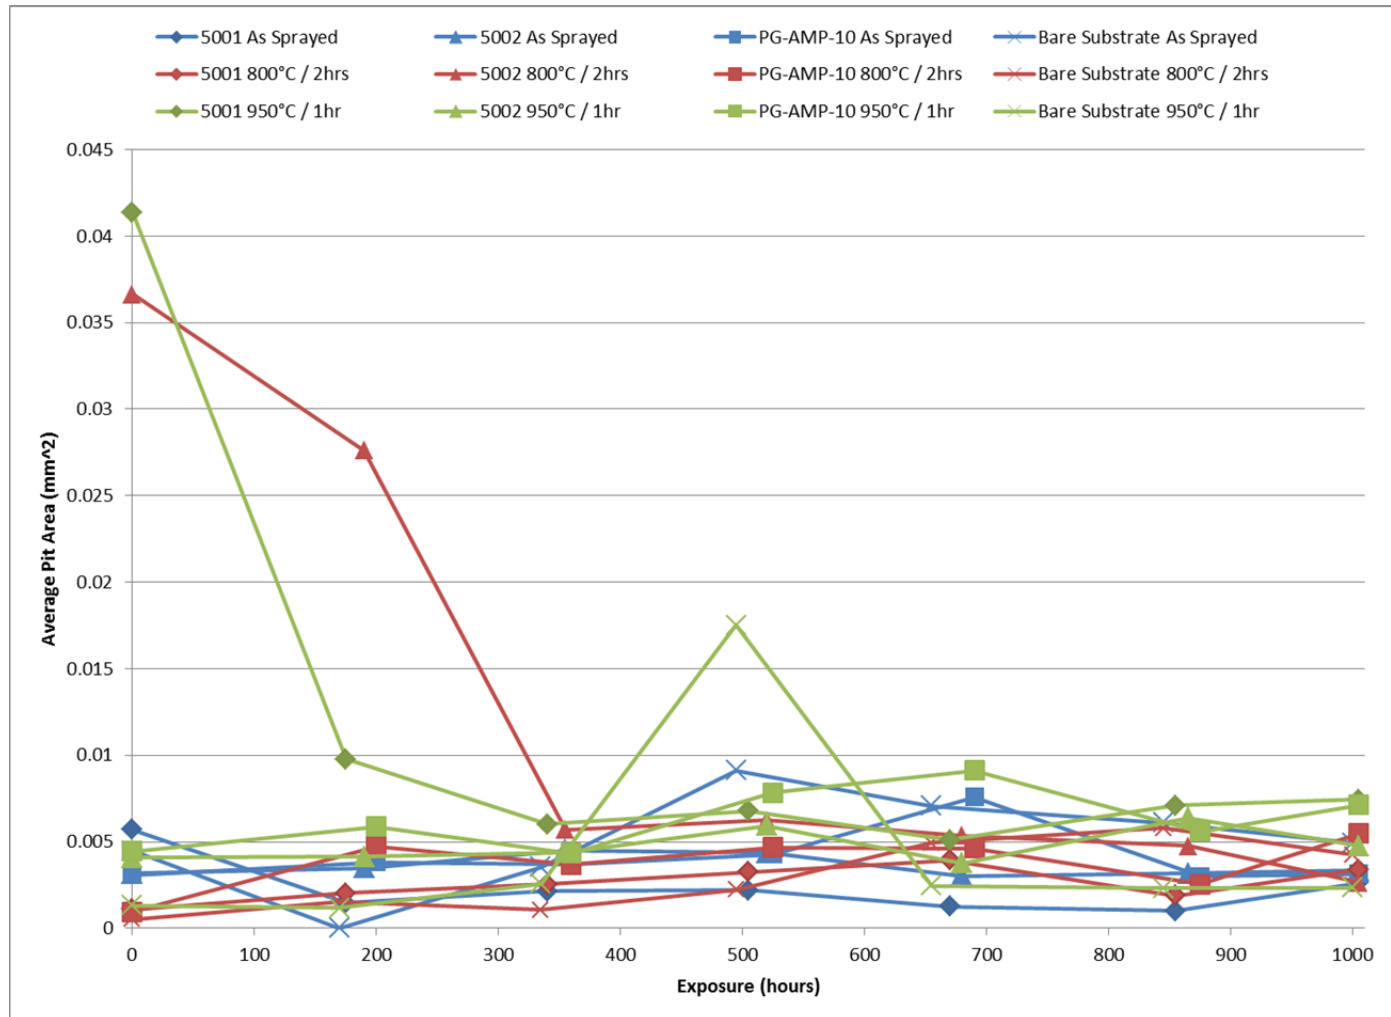
Figure 40. Observed area fraction of sample pitting during weekly sample inspection.

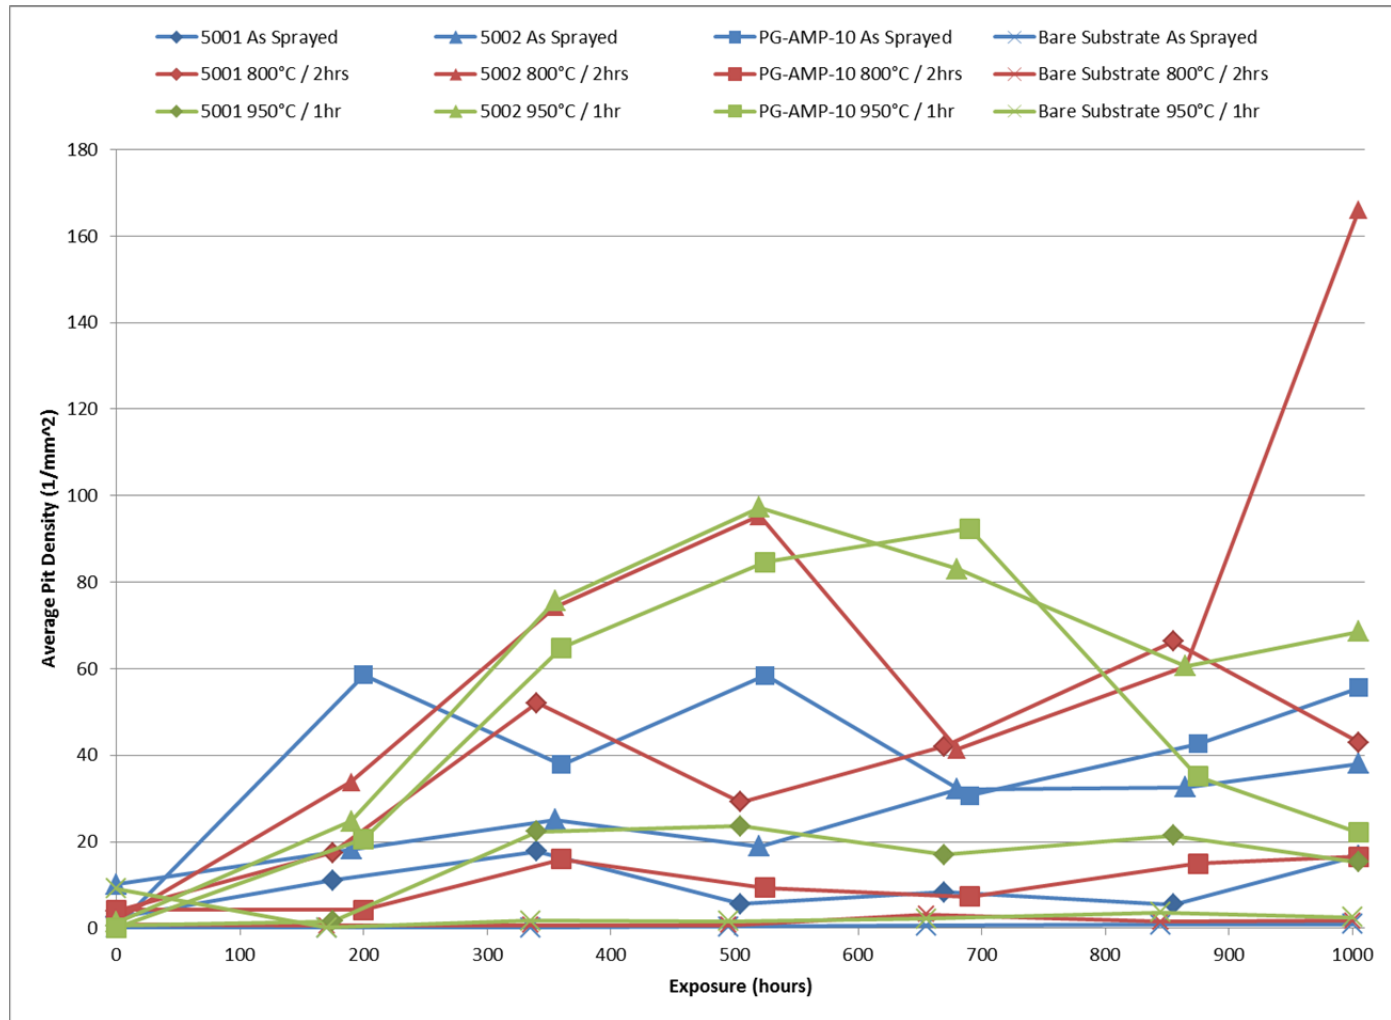
Figure 41. Observed sample pit density during weekly sample inspection.

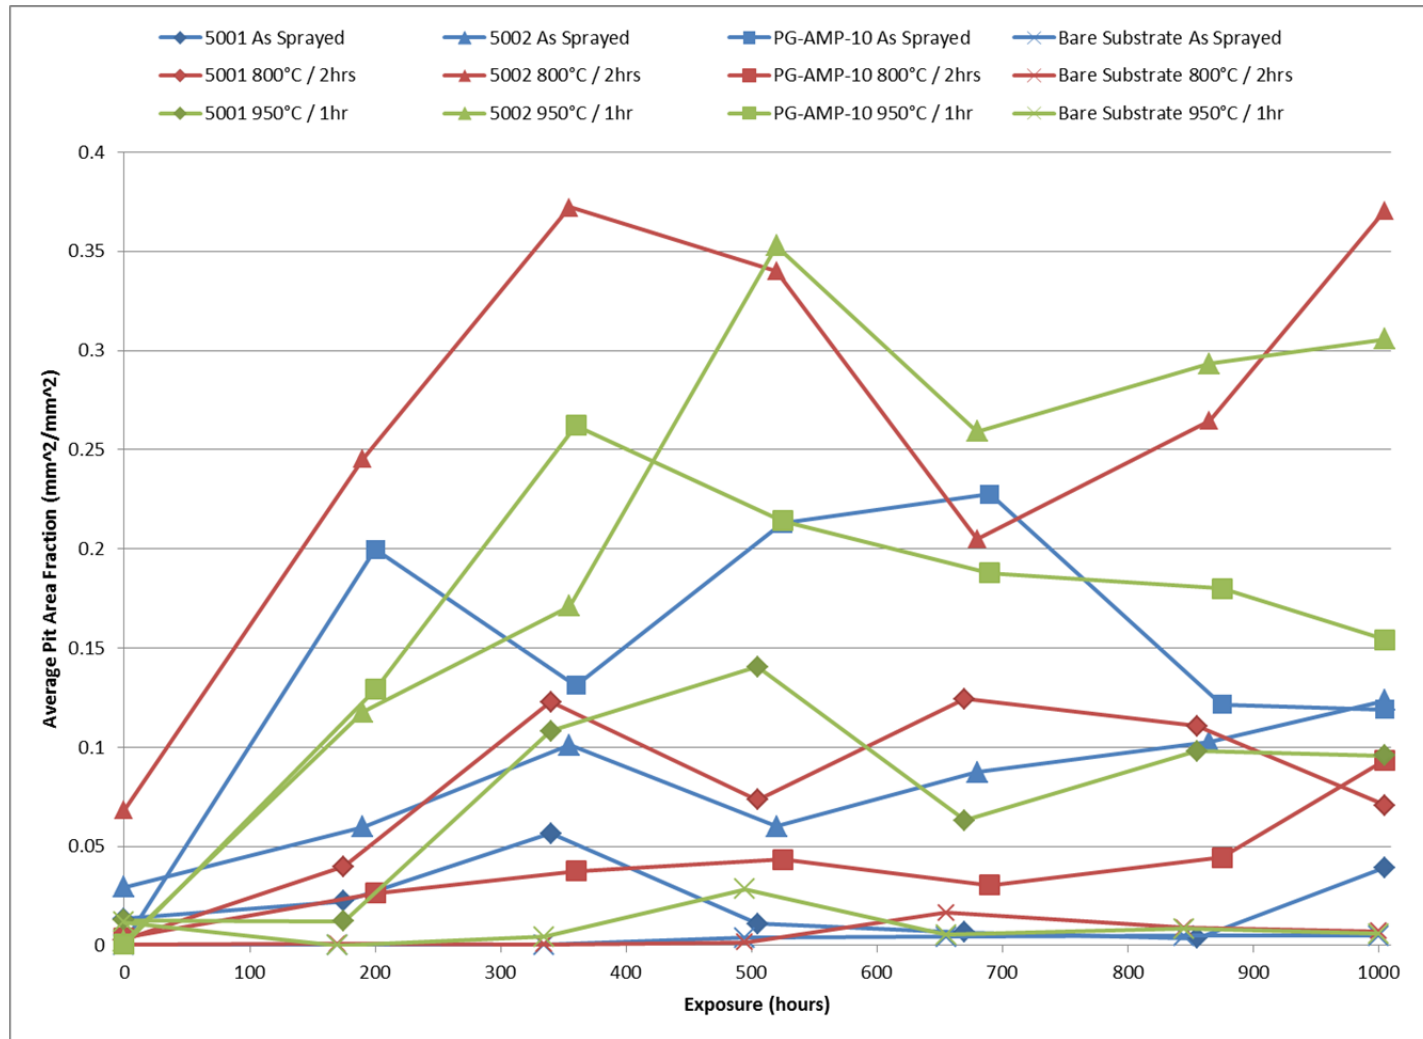
Figure 42. Observed average pit area during weekly inspection.

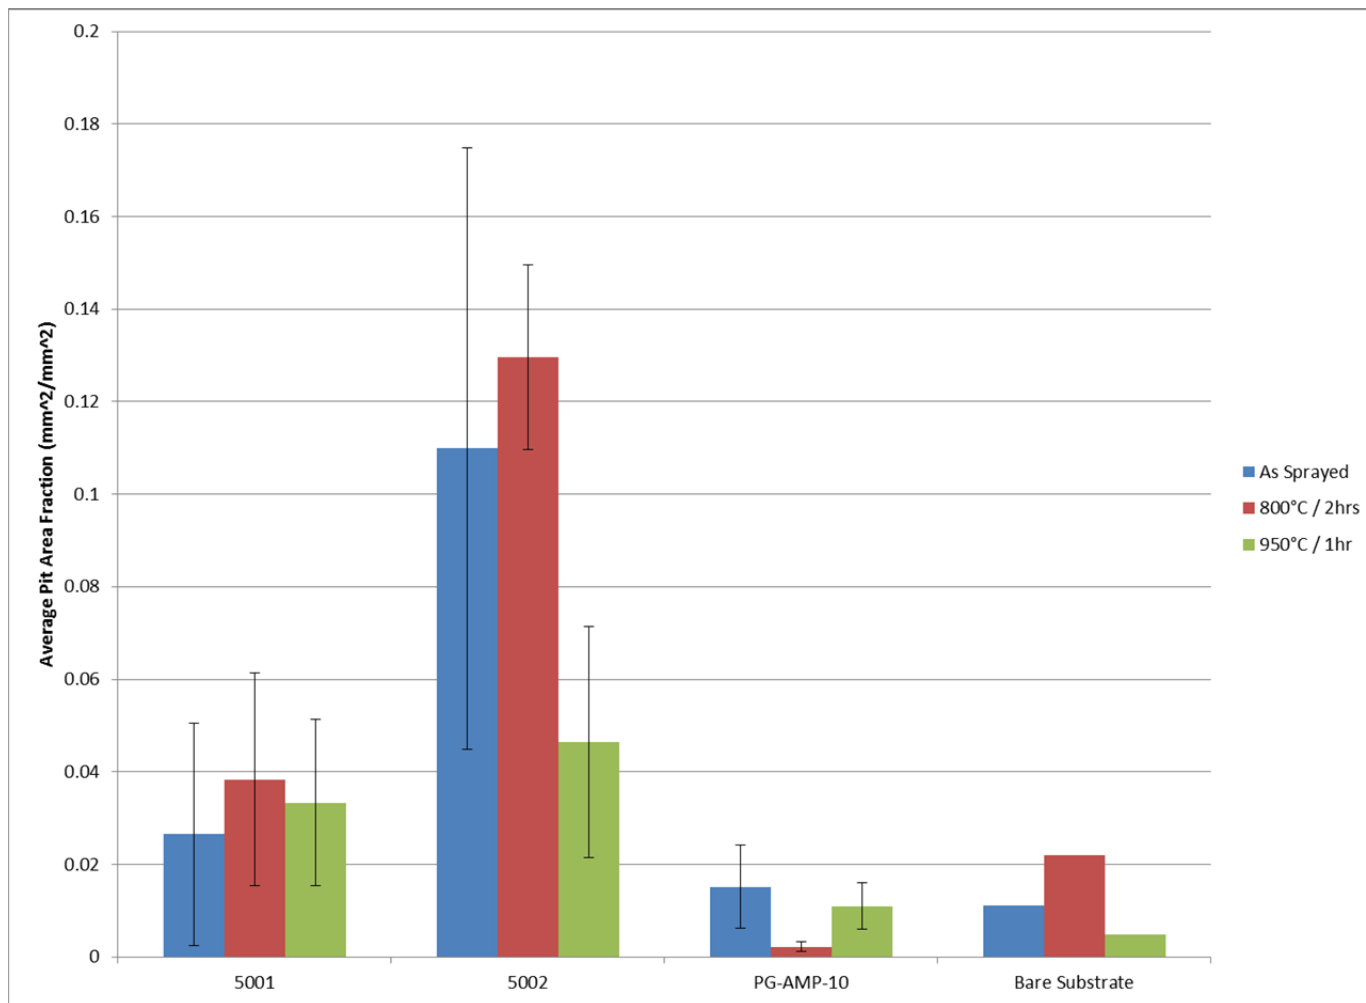
Figure 43. Pit area fraction measured after 1000 hrs salt fog exposure and cleaning with nitric acid.

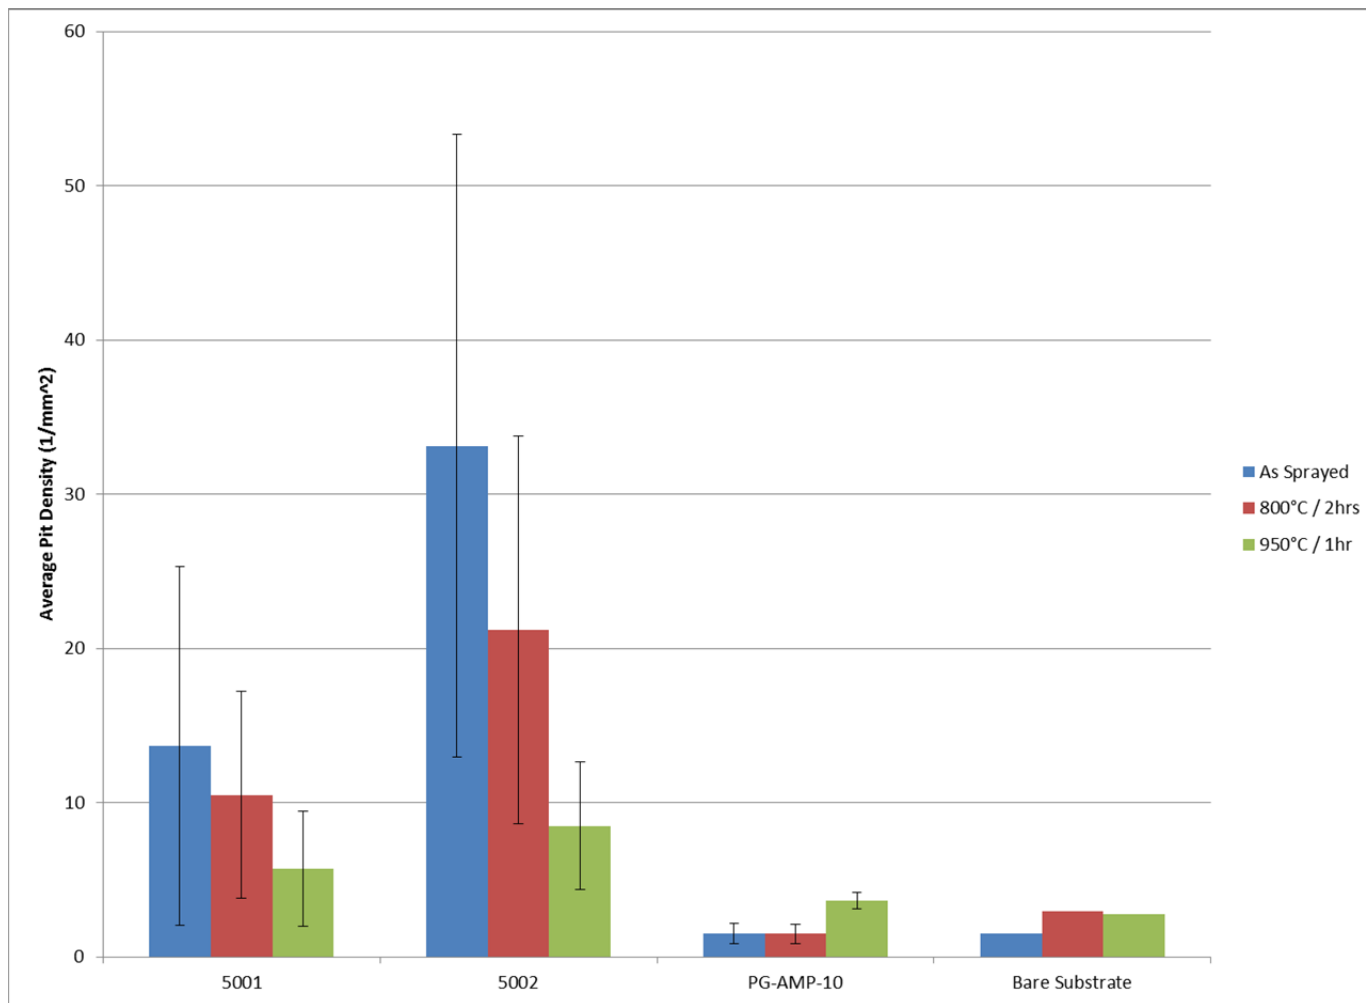
Figure 44. Pit density measured after 1000 hrs salt fog exposure and cleaning with nitric acid.

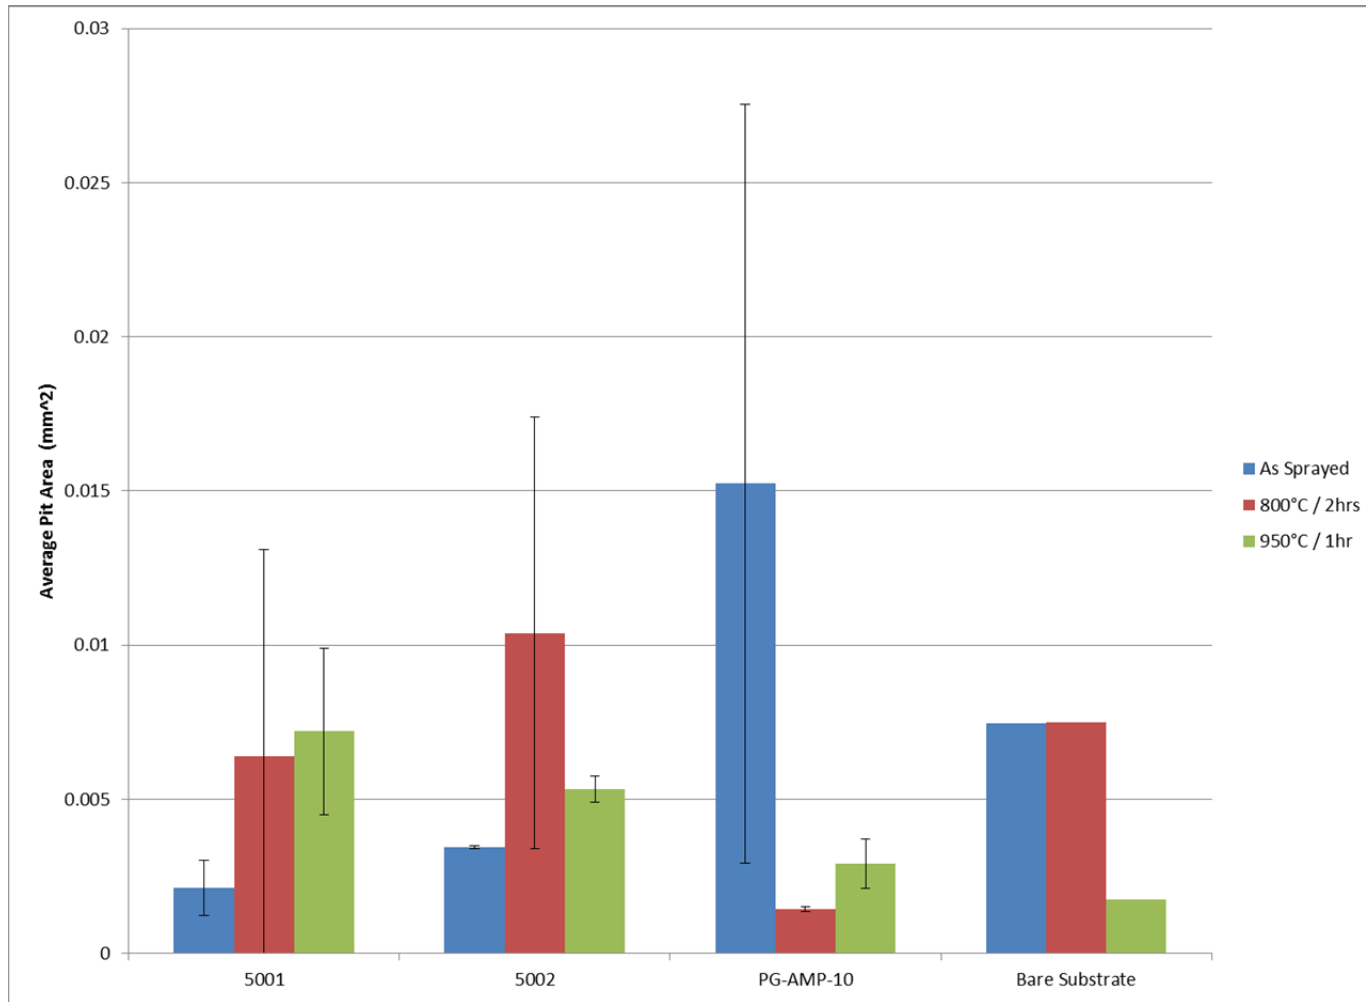
Figure 45. Average pit area measured after 1000 hrs salt fog exposure and cleaning with nitric acid.

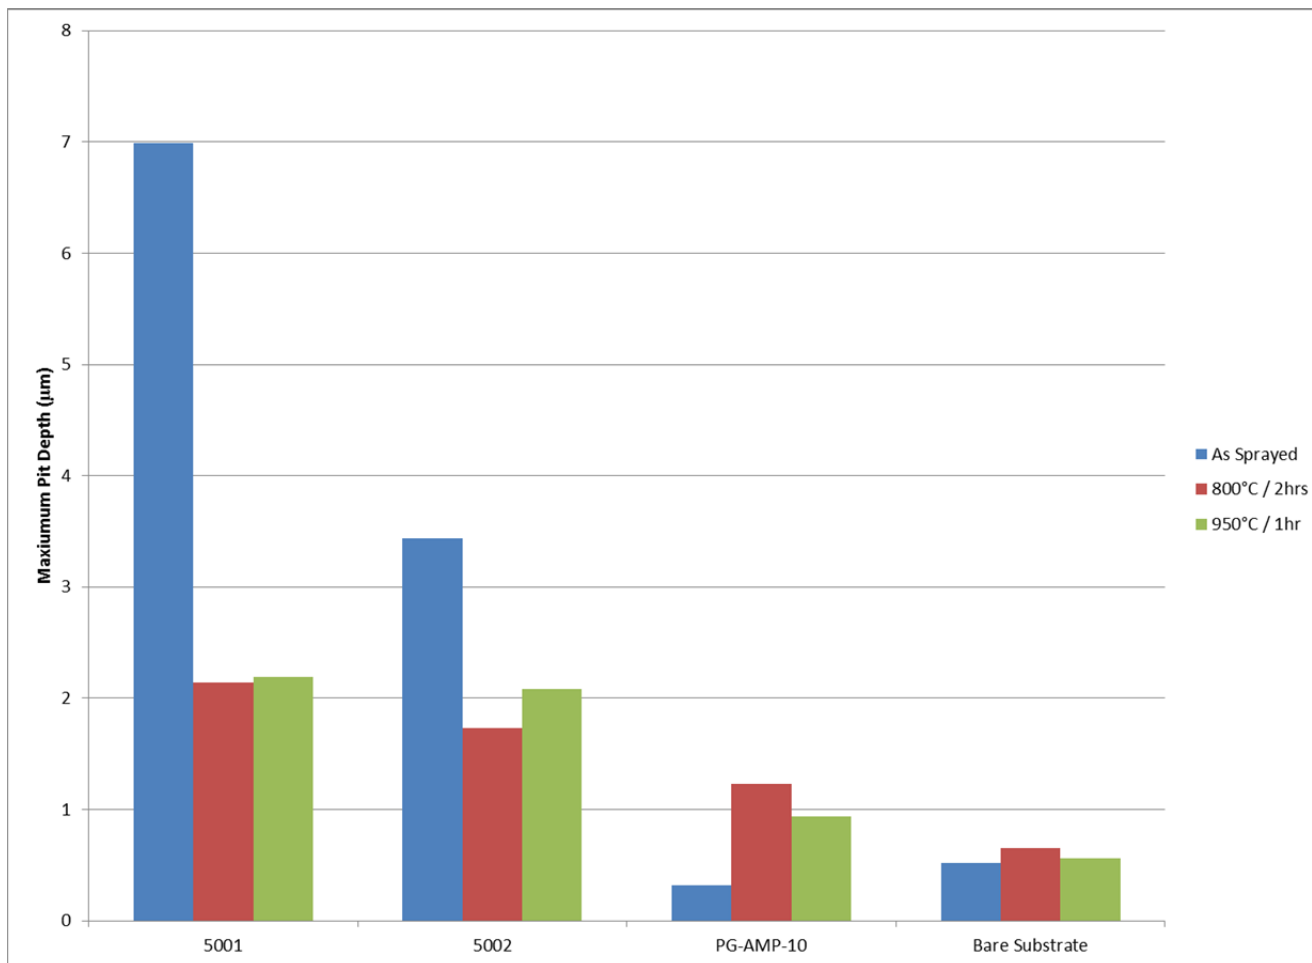
Figure 46. Maximum pit depth observed following 1000 hrs salt fog exposure and cleaning with 10 wt % nitric acid.

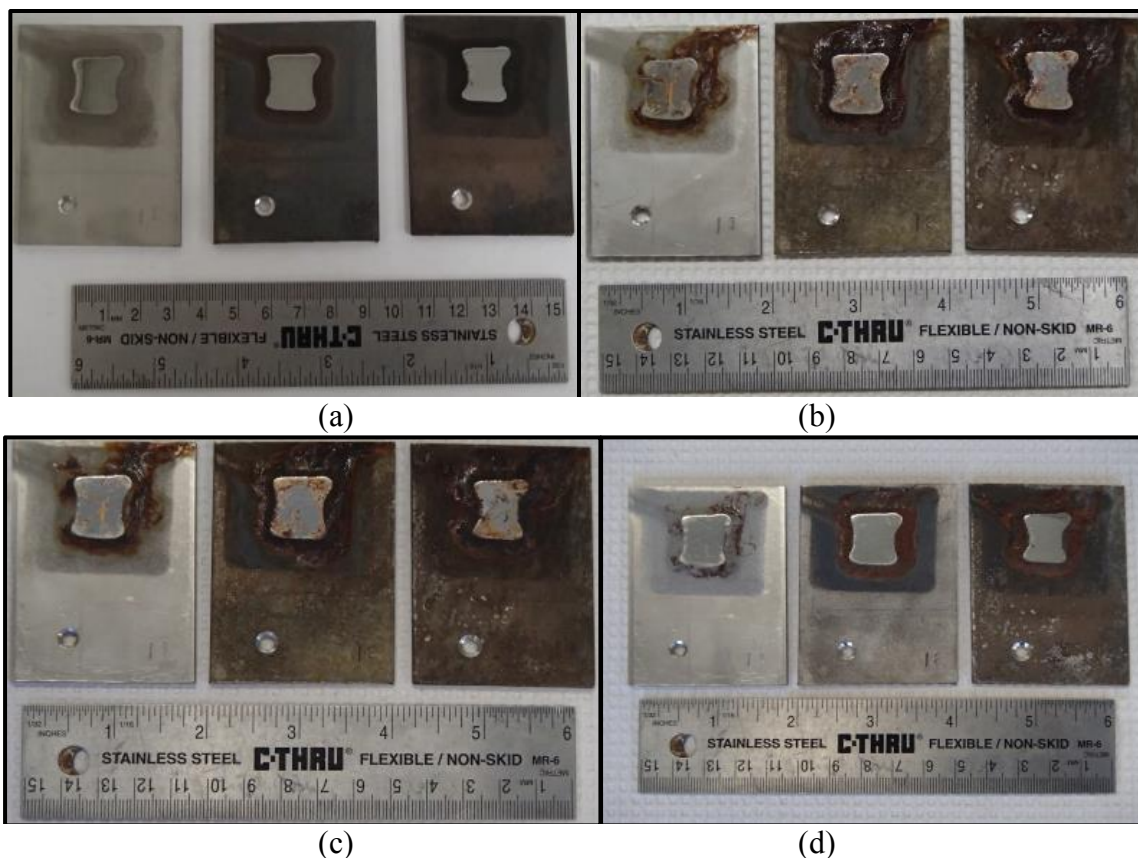
Figure 47. Photographs of samples showing corrosion deposits on sample surface. PG-AMP-10 group 1. (a) initial; (b) 495 hrs; (c) 1000 hrs, cleaned with deionized water and methanol. (d) 1000 hrs, cleaned with 10% nitric acid.

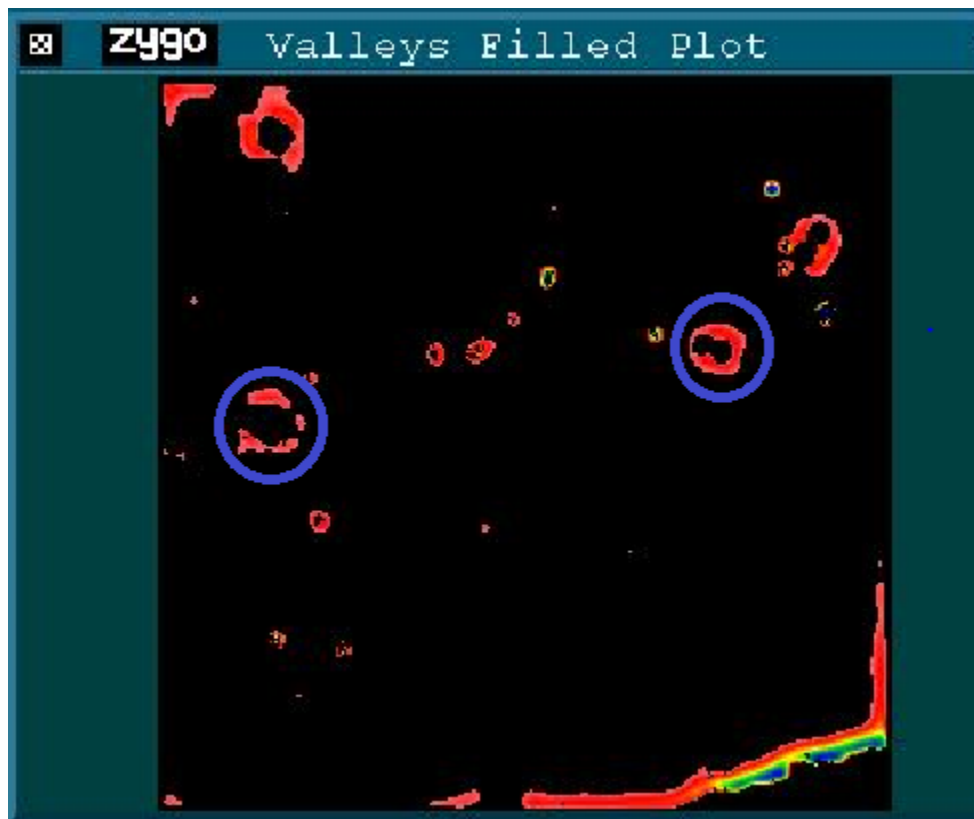
Figure 49. Example resolved valley profile showing pitted regions with unresolved centers (blue circled regions). 5002 powder, 950°C / 1 hr heat treatment. Profile following 1000 hrs exposure and nitric acid cleaning.

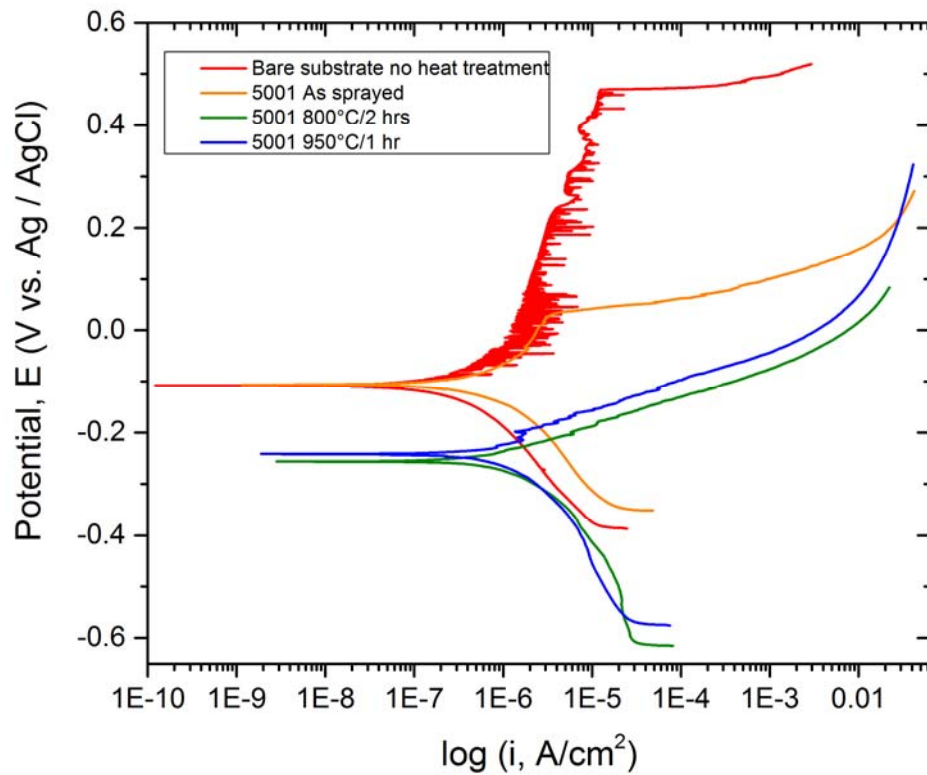
Figure 50. Anodic polarization curves for 5001 powder samples.

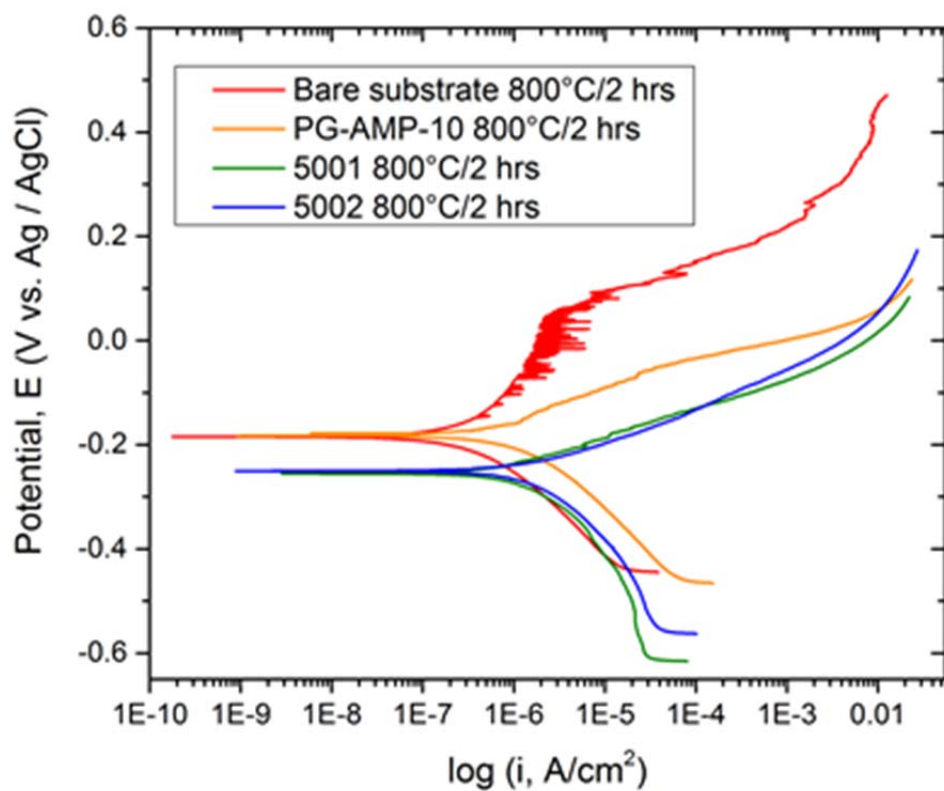
Figure 55. Anodic polarization curves for 800°C/2 hrs heat treated samples.
